Agreement No. CE 32/2021 (CE)  
Improvement Works at Lai Chi Wo Pier and  
Tung Ping Chau Public Pier  
- Design and Construction

Monthly EM&A Report No. 6 for Lai Chi Wo Pier  
(5207869-OR102f -00)

12 August 2022

**Monthly EM&A Report No. 6 for Lai Chi Wo Pier  
[Period from 1 to 31 July 2022]**

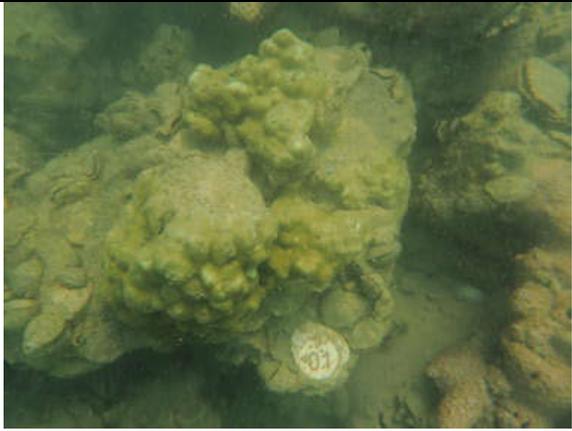
Coral No.	Translocated Coral Colony
1

An underwater photograph showing a large, irregularly shaped coral colony with a porous, yellowish-brown surface. A small, circular white tag with the number '01' is attached to the lower right portion of the colony. The background is a dark, murky underwater environment.
2

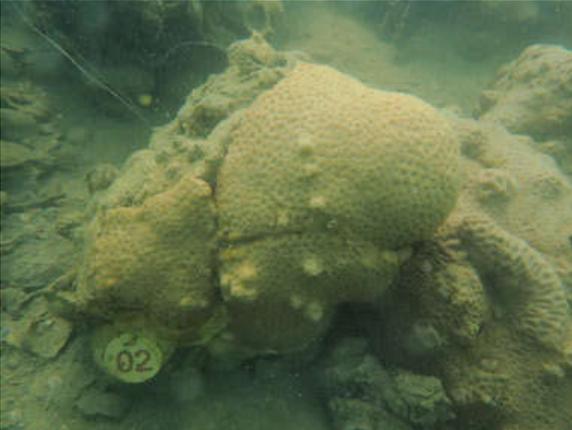
An underwater photograph of a large, rounded coral colony with a highly porous, yellowish-brown texture. A small, circular green tag with the number '02' is attached to the lower left side. The surrounding water is slightly turbid.
3

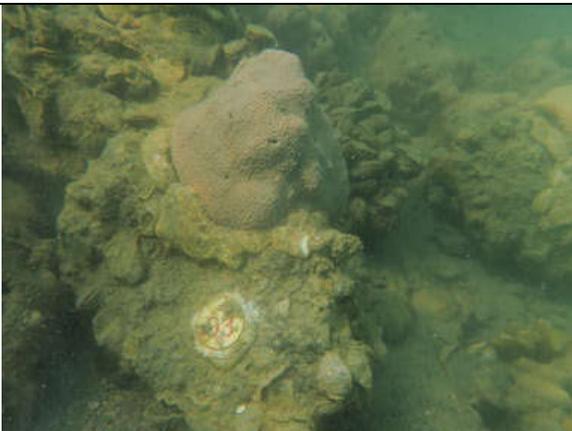
An underwater photograph of a coral colony with a porous, yellowish-brown surface. A small, circular white tag with the number '03' is attached to the lower center. The colony is situated on a rocky substrate.

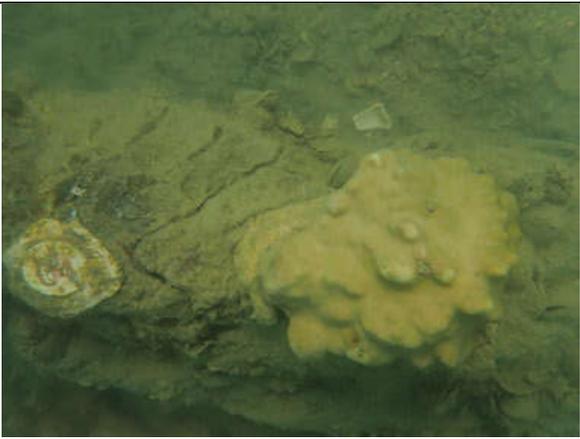
Coral No.	Translocated Coral Colony
4

An underwater photograph showing a coral colony on a rocky substrate. The coral is a pale yellowish-green color and has a somewhat rounded, bumpy appearance. To the left of the main colony, there is a smaller, circular coral structure. The surrounding water is slightly turbid and greenish.

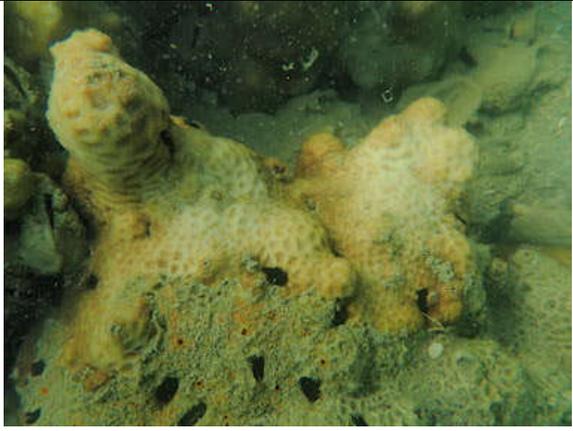
3

2.2.2.14. The tagged natural hard coral colonies existing at the recipient site were also monitored. Except the tagged natural coral colony no. 3, which showed 60% bleaching, no partial mortality, sediment or bleaching in the general condition of these existing natural coral colonies were observed during the monitoring.

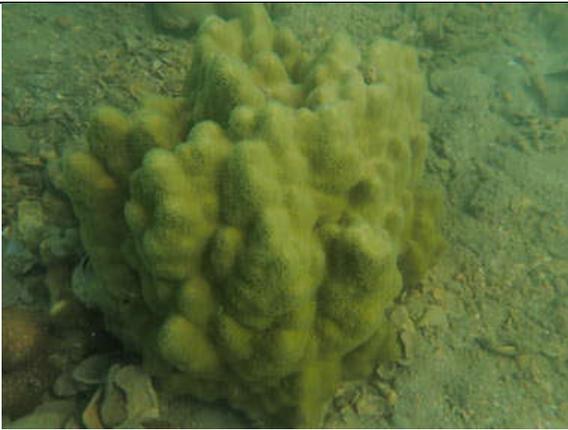
Coral No.	Tagged Natural Coral Colony
10

A photograph of a large, green, bumpy coral colony on a sandy seabed. The coral has a textured, almost cauliflower-like appearance with many small, rounded protrusions. It is situated on a light-colored, sandy bottom with some scattered debris and other smaller coral fragments visible in the background.
